FOREST PRODUCTS RESEARCH IN PICTURES

NO. 22

FUNGUS ATTACK ON CUT END OF TREATED PILE

FOREST PRODUCTS LABORATORY
U. S. FOREST SERVICE
MADISON, WISCONSIN

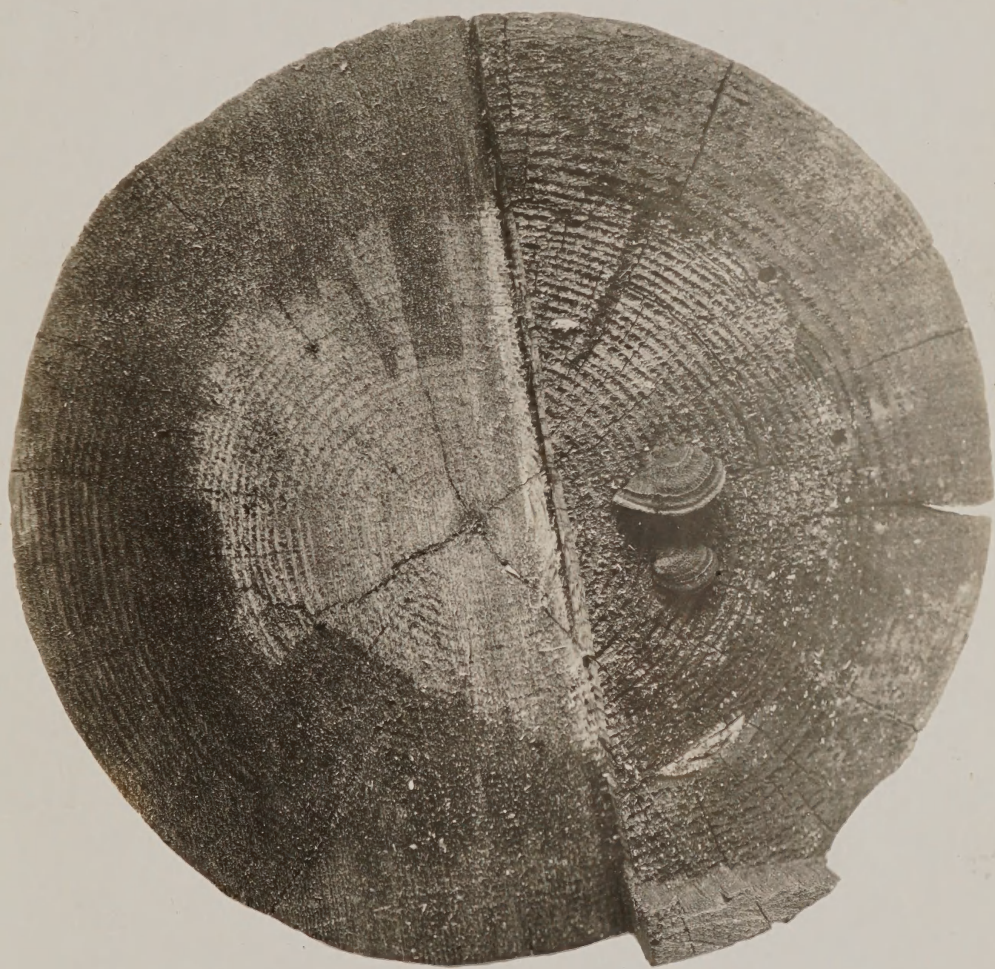
The photograph shows a wood-destroying fungus growing in the untreated wood exposed by cutting off the end of a creosoted pile. The end was given no protective treatment after it had been cut.

It is possible that there was slight decay in the pile before it was treated so that cutting off the end merely allowed the fungus to fruit, or the fungus may have entered after the untreated wood was exposed. After the end of a creosoted timber is trimmed, it should be given two or three brush coats of hot creosote at once. This will hold back the growth of the fungus if it is already in the wood, or, if the wood was sound when treated, it will prevent infection afterward.
